ENGINEERING INVESTIGATIONS AT INACTIVE HAZARDOUS WASTE SITES

PHASE II INVESTIGATION

Old Amenia Landfill Site No. 314006
Town of Amenia Dutchess County, New York

DATE: April 1993

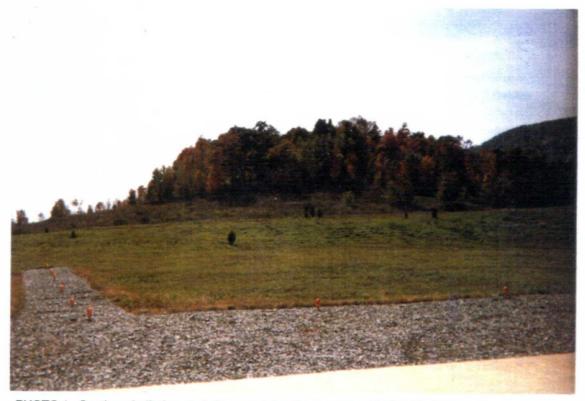
PHOTO 1. Southern half of central site area, taken from center of helipad looking south.

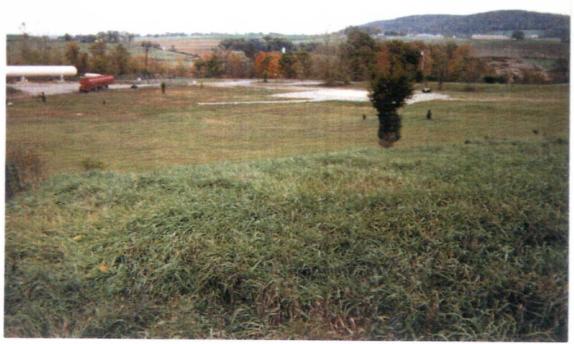
PHOTO 2. Helipad and central site area, taken from top of ridge in southwestern portion of site looking northeast.

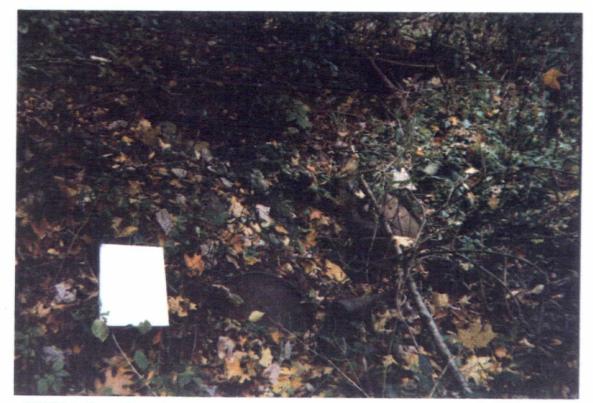
PHOTO 3. Drum disposal area west of access road near southern end.

at this location. The other test pit should be located in the drum disposal area to determine the condition of the drums and whether any of the drums contain industrial wastes that can be sampled.

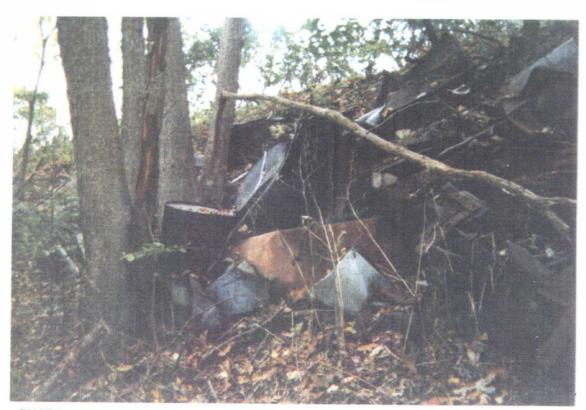
PHOTO 4. Scrap metal disposal area on western bank of site near northern end of access road.

Two more test pits are recommended in the southern portion of the site. One trench should be located near the scrap metal disposal area at the northern end of the access road leading to the drum disposal area. The purpose would be to investigate the small magnetic anomaly

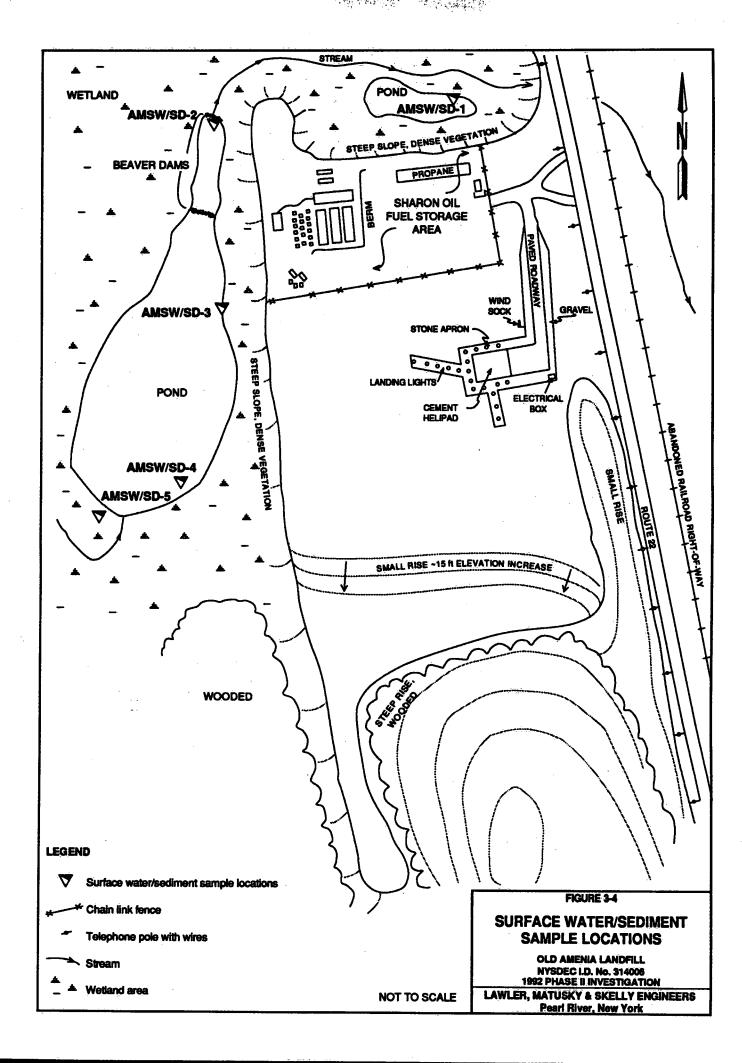
An LMS crew sampled surface water and sediments according to NYSDEC protocols at five locations (Figure 3-4) between 20 and 23 November 1991 (Ref. 5). All locations were selected by LMS personnel according to work plan recommendations and were approved by a NYSDEC representative before sampling commenced. Surface water/sediment sample AMSW/AMSD-1 was collected from the stream in the wetland area that borders the landfill to the north. AMSW/AMSD-2 through -5 were collected from the pond that borders the landfill on the west.

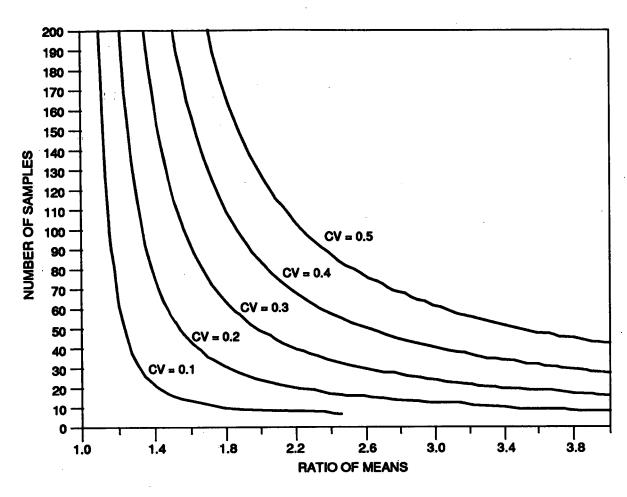
#### FIGURE 4-5

- CV Coefficient of variation
- Probability of a Type I error (say there is a difference when there is none -- consequence is remediation where none is needed)
- β Probability of a Type II error (say there is no difference when there really is -- consequence is no remediation at a site that needs it)

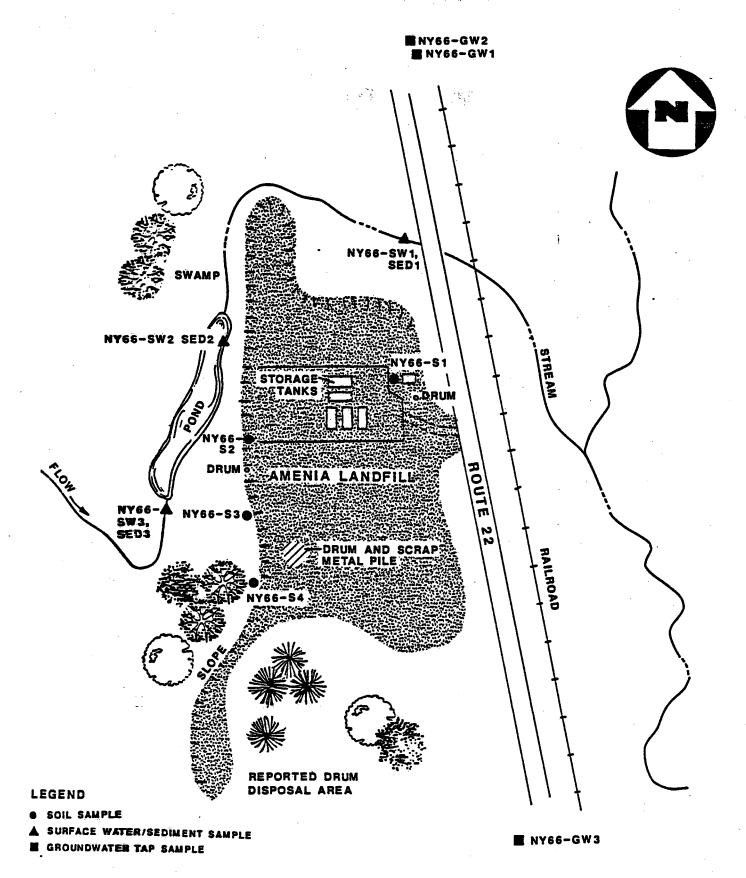
SAMPLE LOCATION MAP

All samples collected during this investigation will be analyzed for Hazardous Substance List (HSL) Parameters. A total of thirteen (13) environmental samples were collected from the site. Four (4) soil, three (3) surface water and three (3) sediment samples were collected onsite. Three (3) groundwater tap samples were collected off-site. One aqueous QA/QC blank was obtained from the EPA laboratory in Edison, New Jersey and was shipped with the environmental samples. Sample packaging and shipping was performed in accordance with NUS OGM 4.19.
